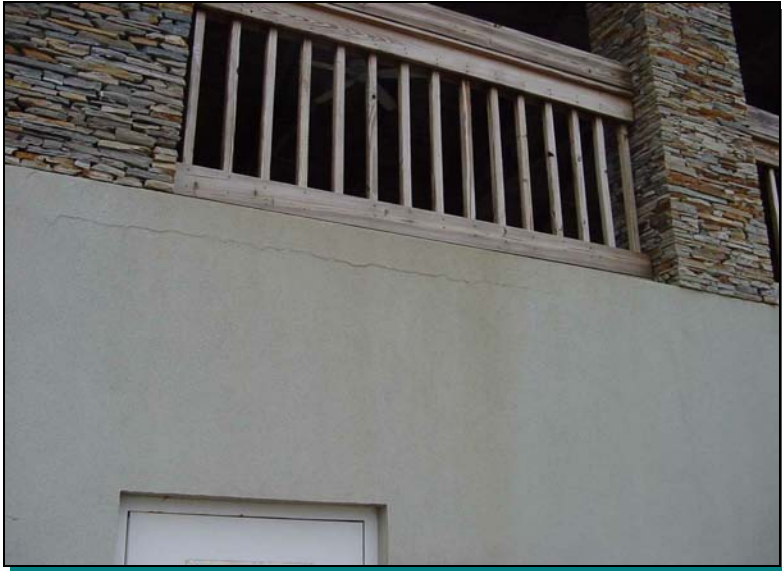
Crack in parge coat where concrete deck meets concrete block wall - typical at perimeter

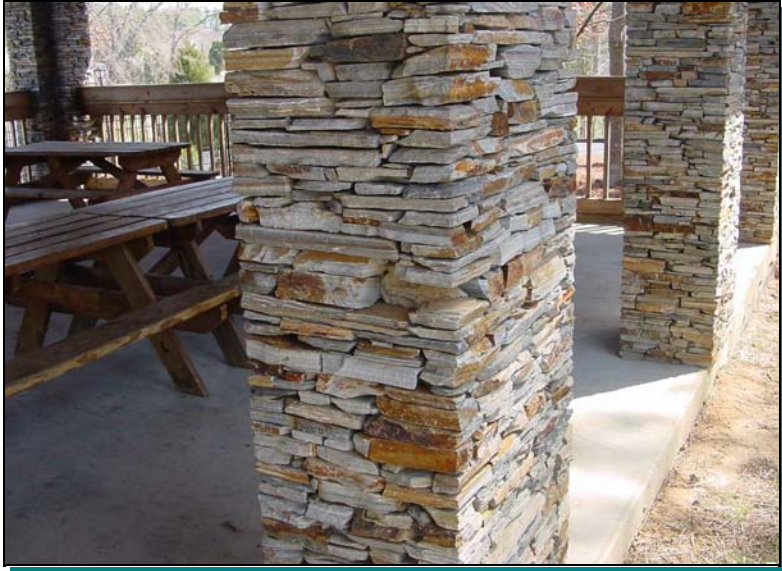
Missing stones at column

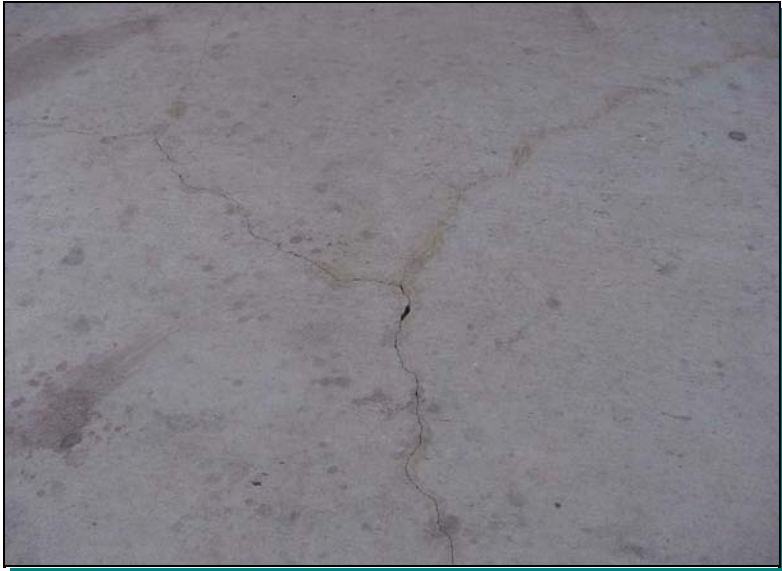
Cracks in concrete deck

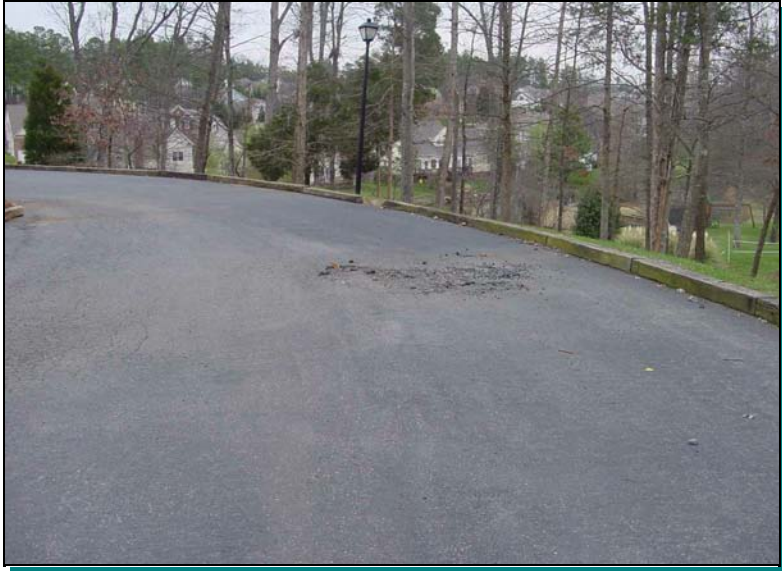
Pavement deterioration

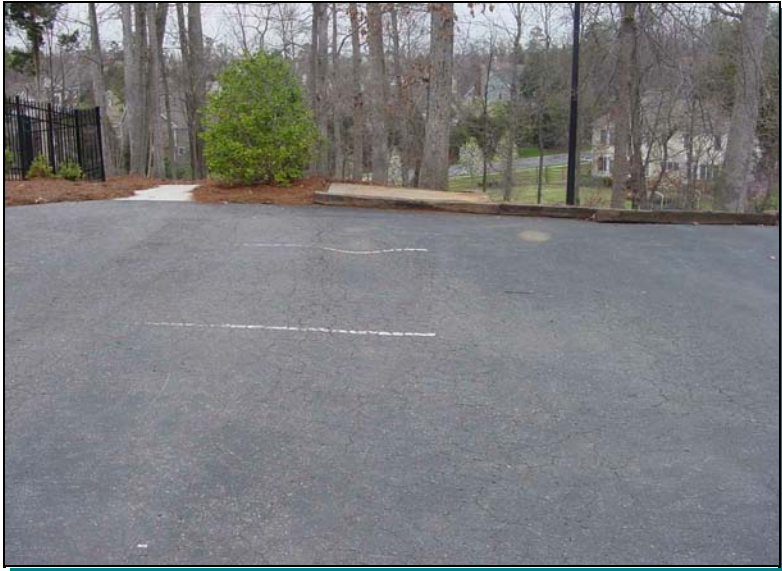
Pavement deterioration

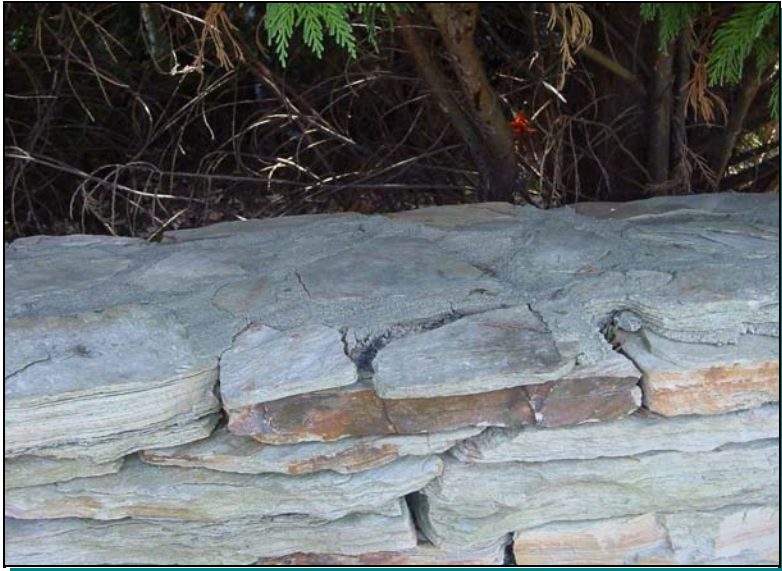
Mortar deterioration

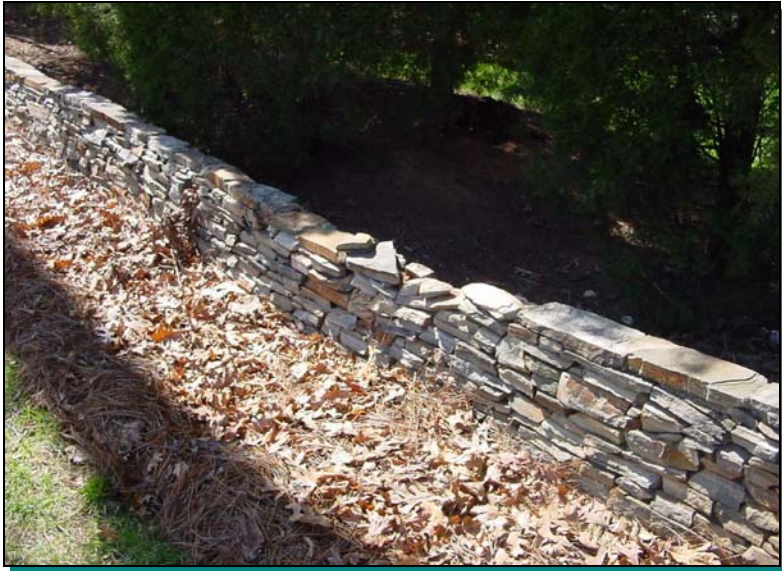
Monument wall deterioration

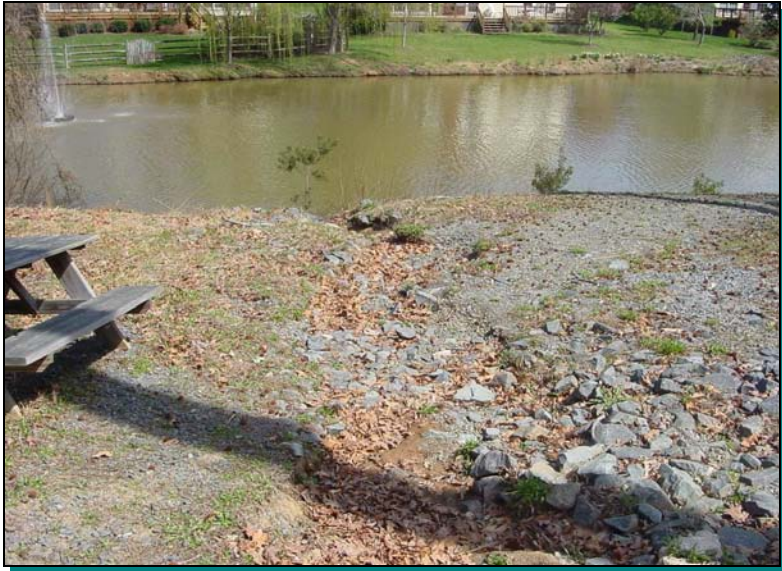
Erosion at pond

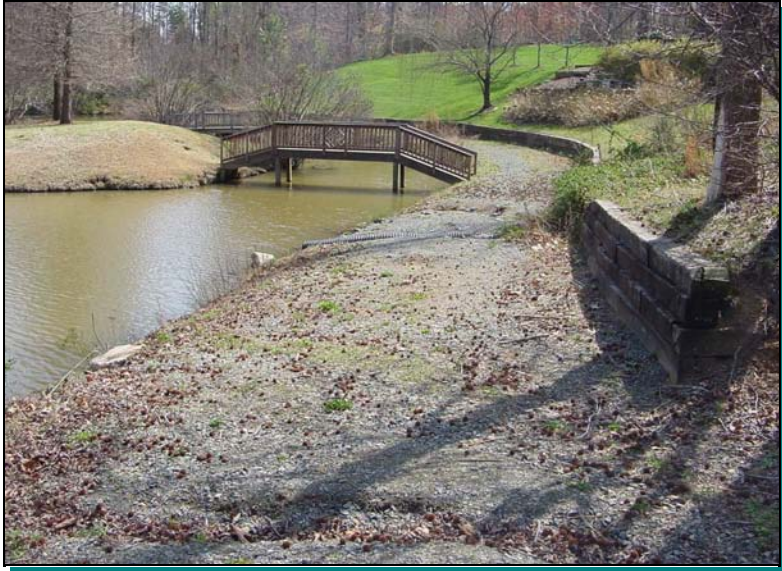
Pond erosion, wood retaining wall and wood bridges

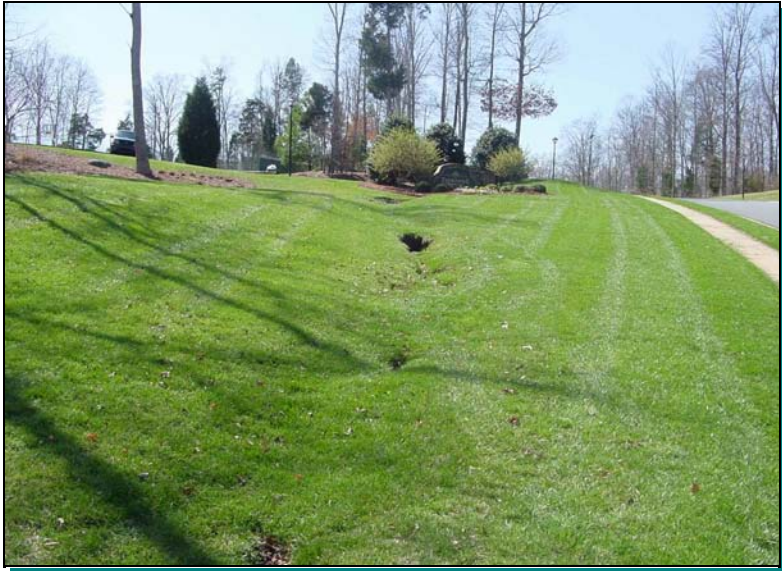
Erosion near pavilion

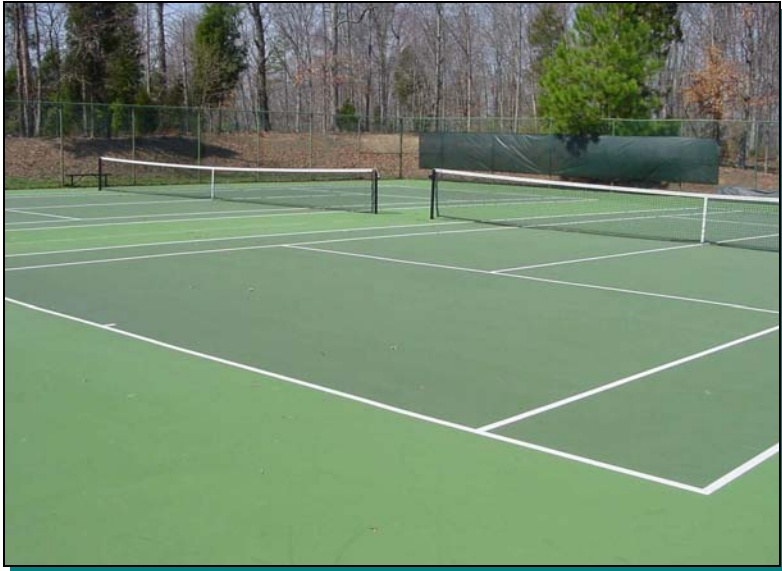
Tennis courts in good condition

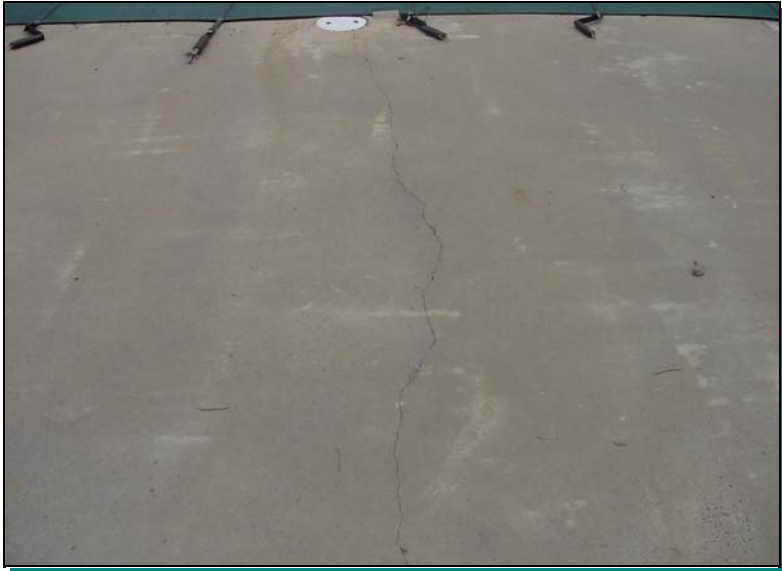
Minor crack in pool deck

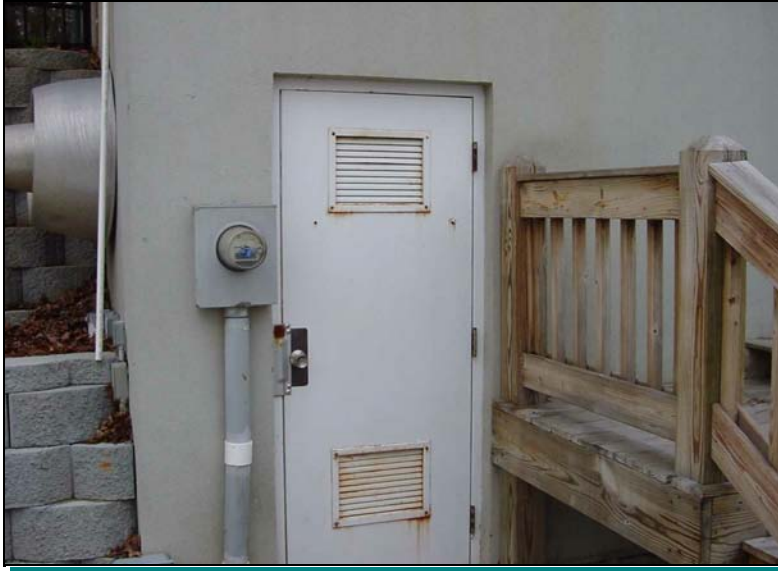
Rusted metal door - typical of all metal doors

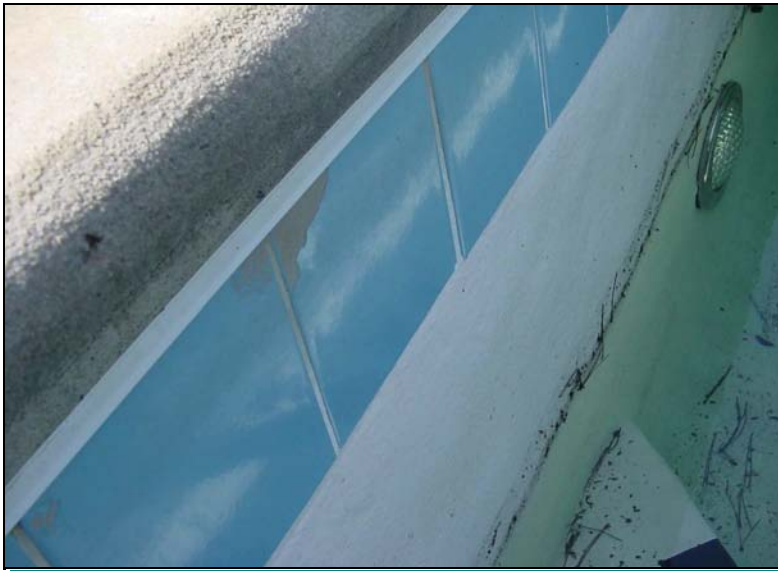
Fiberglass pool coating and minor tile deterioration
